HISTORIC MONROE STATION
STABILIZATION
at
BIG CYPRESS NATIONAL PRESERVE
BICY Contract No. C5120085452

EXISTING
SOUTH AND WEST
DEMOLITION
ELEVATIONS

A-2.2

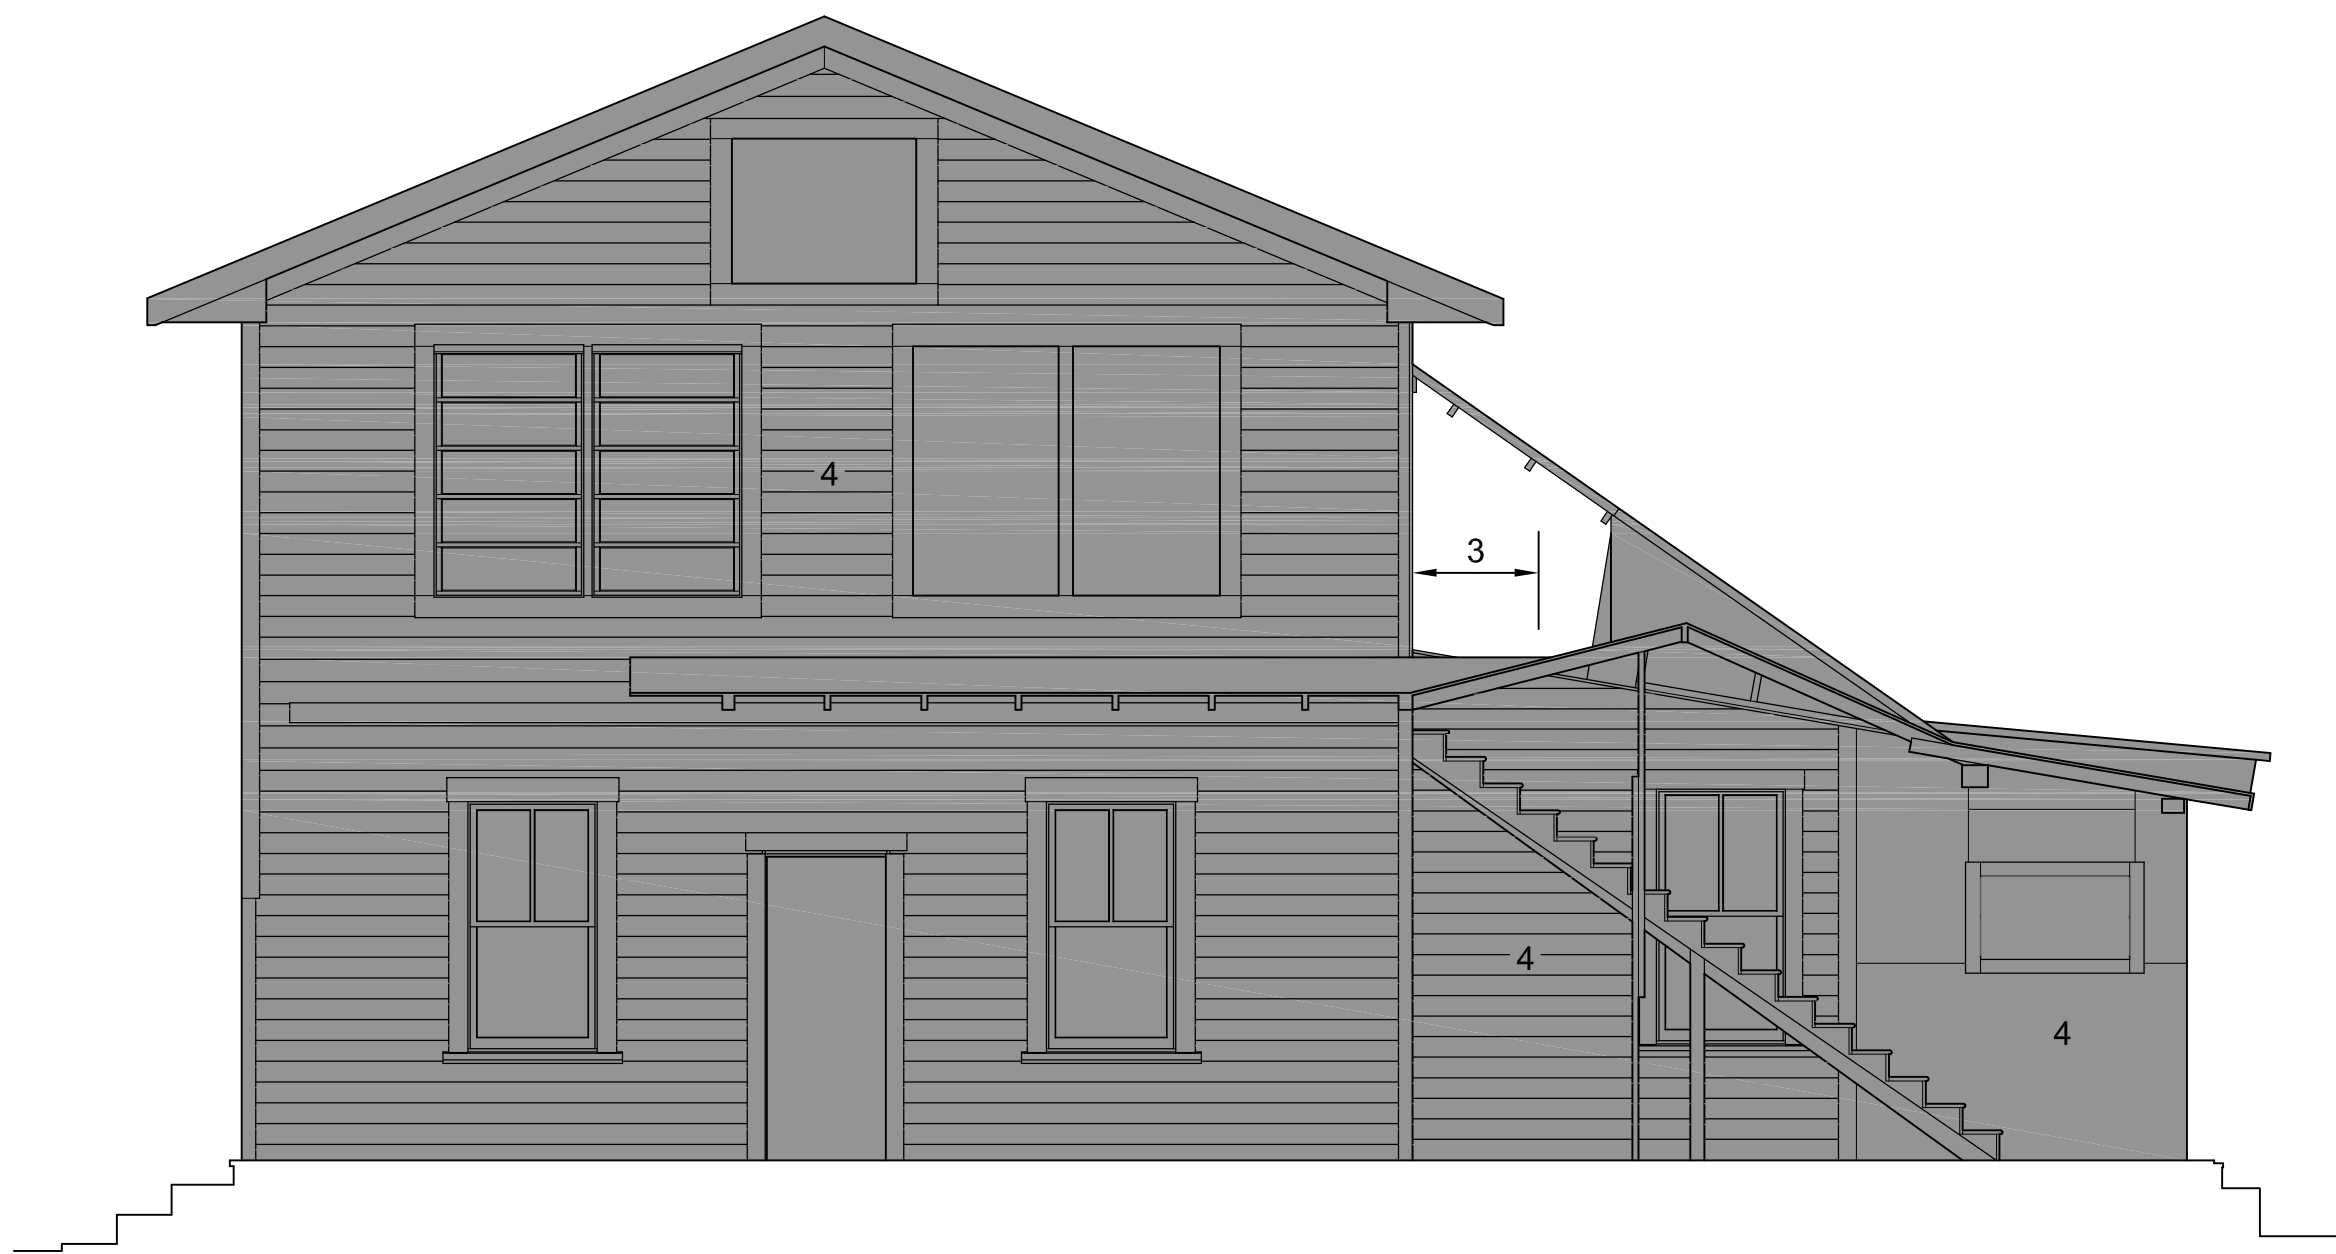
② EXISTING AND DEMOLITION
MONROE STATION SOUTH ELEVATION
SCALE: 1/4" = 1'-0"

1. ROOF PROFILE OF ORIGINAL HISTORIC MONROE STATION IS STILL INTACT. ROOF JOISTS, AND SHEATHING HAS BEEN OBSERVED. MAINTAIN ORIGINAL HISTORIC HIP ROOF PROFILE.

2. DASHED LINE REPRESENTS ORIGINAL MONROE STATION BUILDING PROFILE. HISTORIC PLANE OF FIRST FLOOR STILL EVIDENT. HISTORIC SECOND FLOOR WALLS AREAS STILL INTACT. REFER TO EXISTING FLOOR PLANS ON SH. A2.1 FOR ADDITIONAL INFORMATION.

3. USE SELECTIVE DEMOLITION TO REMOVE ONE STORY, TWO STORY AND ROOF ADDITIONS FROM THE ORIGINAL BUILDING. REFER TO EXISTING FLOOR PLANS ON SH. A2.1 FOR ADDITIONAL INFORMATION.

4. REMOVE NON-HISTORIC ELEMENTS OF EXISTING BUILDING INCLUDING EXISTING FOUNDATIONS. REFER TO EXISTING FLOOR PLANS ON SH. A2.1 FOR ADDITIONAL INFORMATION.

5. REMOVE EXISTING SHINGLE ROOFING SYSTEM. EXISTING HISTORIC ROOF SHEATHING AND ROOF STRUCTURE TO REMAIN. COORDINATE REMOVAL OF EXISTING ROOFING SYSTEM WITH INSTALLATION OF NEW ROOFING SYSTEM TO ENSURE WATERPROOFING AT ALL TIMES DURING CONSTRUCTION.

6. REMOVE AND DISCARD NON-HISTORIC FASCIA FABRIC. CONFER WITH ARCHITECT IN FIELD BEFORE REMOVAL.
7. HISTORIC WOOD BRACKETS TO BE CAREFULLY REMOVED AND REHABILITATED. REFER TO ELEVATION SHEET A4.1 FOR ADDITIONAL NOTES.

8. REMOVE AND DISCARD NON HISTORIC TRIM.
9. REMOVE TOP WOOD BOARD SIDING FOR RECONSTRUCTED TRIM. REFER TO WEST ELEVATION SH. A4.1 FOR NOTES ON RECONSTRUCTED TRIM.

10. HISTORIC TRIM TO BE REMOVED FOR REHAB AND RE-INSTALLED IN SAME LOCATION.
11. CONFIRM EXISTING HISTORIC WINDOW TRIM IS NOT DETERIORATED BEYOND REPAIR. WHERE DETERIORATED BEYOND REPAIR, RECONSTRUCT TO SAME SIZE AND SHAPE TO MATCH HISTORIC TRIM. WHERE EXISTING HISTORIC TRIM IS SALVAGEABLE, STRIP OFF PAINT AND REHABILITATE. CONFER WITH ARCHITECT ON-SITE.

12. CONFIRM EXISTING WINDOW SILL IS NOT DETERIORATED BEYOND REPAIR. WHERE DETERIORATED BEYOND REPAIR, RECONSTRUCT TO SAME SIZE AND SHAPE TO MATCH HISTORIC SILL. WHERE EXISTING HISTORIC SILL IS SALVAGEABLE, STRIP OFF PAINT AND REHABILITATE. CONFER WITH ARCHITECT ON-SITE.

16. REMOVE EXISTING CONCRETE STEPS.
17. REMOVE EXISTING NON-HISTORIC PLYWOOD SOFFIT TO EXPOSE HISTORIC WOOD STRIP SOFFIT. CONFER WITH ARCHITECT TO DETERMINE EXTENT OF SALVAGEABLE MATERIAL.
